CARPET STORE FIRE

Branford, CT

November 28, 1996

**Carpet Store Fire
One Fire Fighter Fatality
Branford, CT
November 28, 1996**

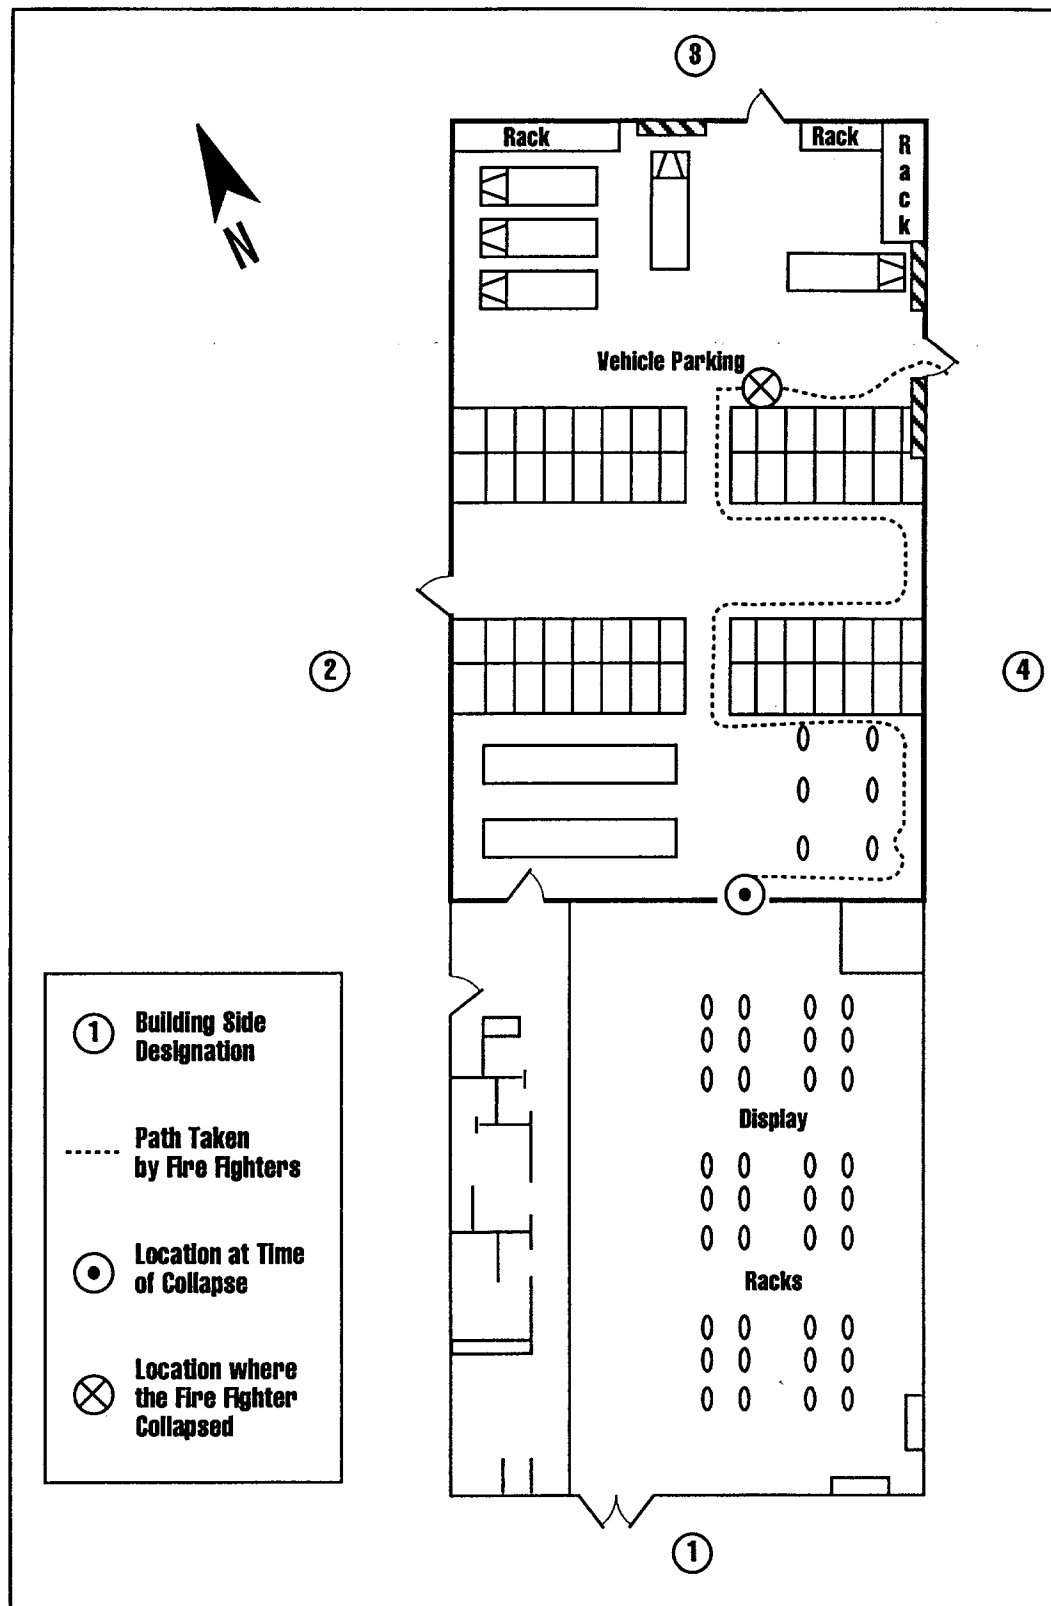
Figure 3: Path taken by fire fighters in their attempt to escape

When the trapped officer and fire fighter entered the part of the warehouse where the vehicles were parked, the Medic 1 fire fighter's air ran out. He took off his face piece and continued further only a short way. He was overwhelmed by the smoke and collapsed approximately 40 ft (12.2 m) from a door. The fire officer tried to pull the fire fighter out of the building but he was too big and heavy. The officer decided to continue on so he could find an exit and get assistance.

The officer found one of the overhead garage doors. This door was covered by wood boards, and the officer realized that he could not open it. He continued to search in the darkness and smoke until he found a personnel door. It was locked. Unable to see the door, he began feeling the entire door to determine what type of lock or locks

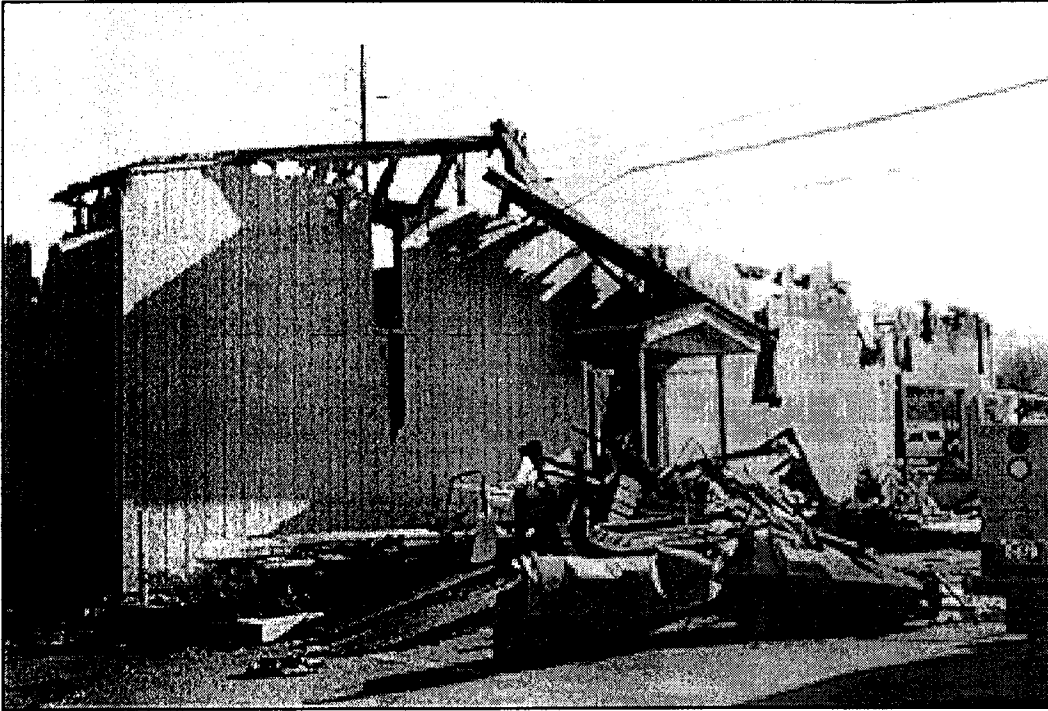
Photo 1: Front of building (Side 1)

The entire building was destroyed by this fire. All of the wood trusses above the warehouse area and most of the wood trusses above the two showrooms were consumed. The most severe damage to building contents occurred in the warehouse, and in ceiling and tile showroom. In these areas, nearly all of the combustible and flammable materials were consumed. The contents of the carpet showroom were heavily damaged and in the office area furnishings, office equipment, and other combustible materials were moderately damaged. (*See Photos 1 – 4.*)

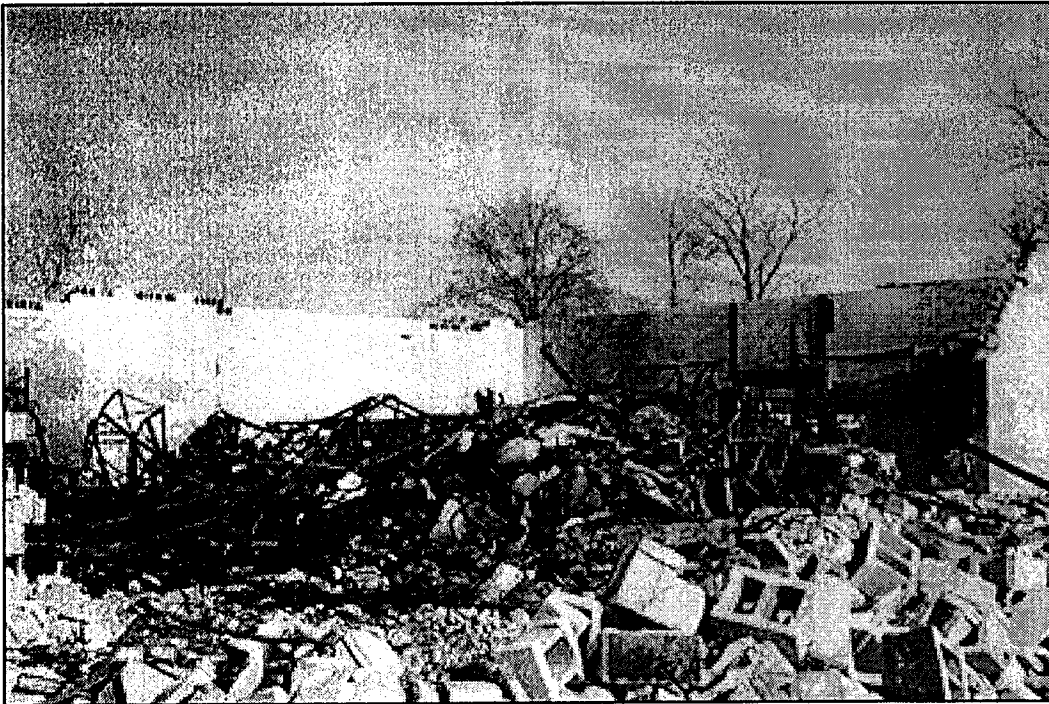
Photo 4: Right side of building (Side 4)
Note: The men are standing in an area where walls had been removed for the cause investigation

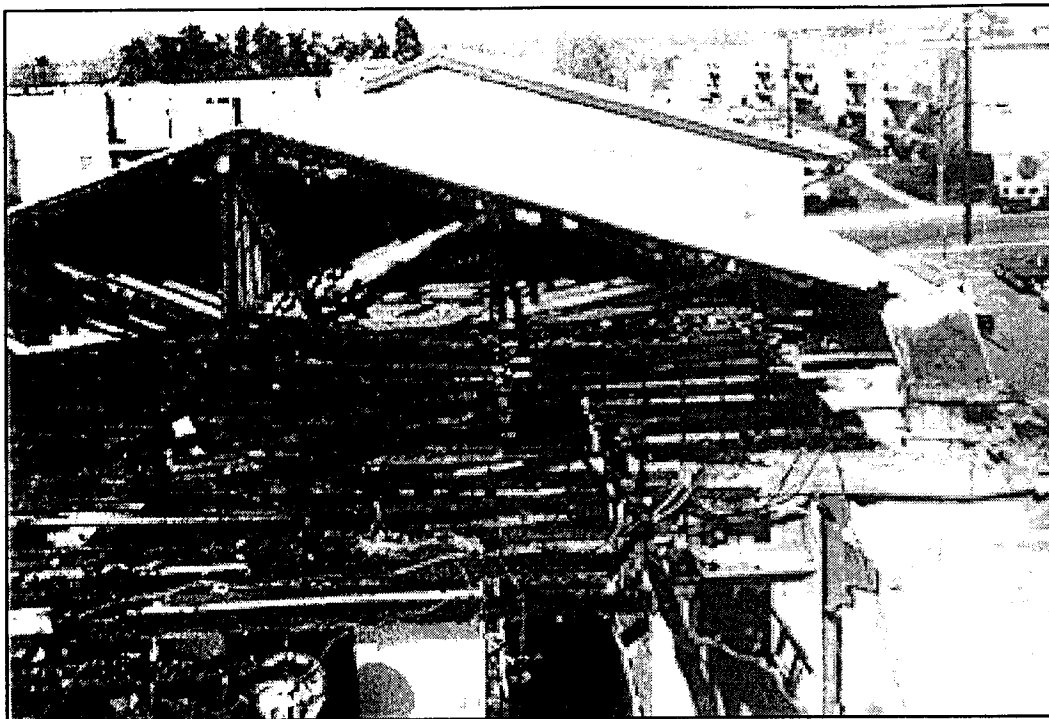
Photo 5: Collapsed roof trusses over an apartment building.
Credit: Francis Brannigan, used with permission
